Initial Site analysis Location Option 1

Project ref: A1625 - Issue 02 - 17.01.23

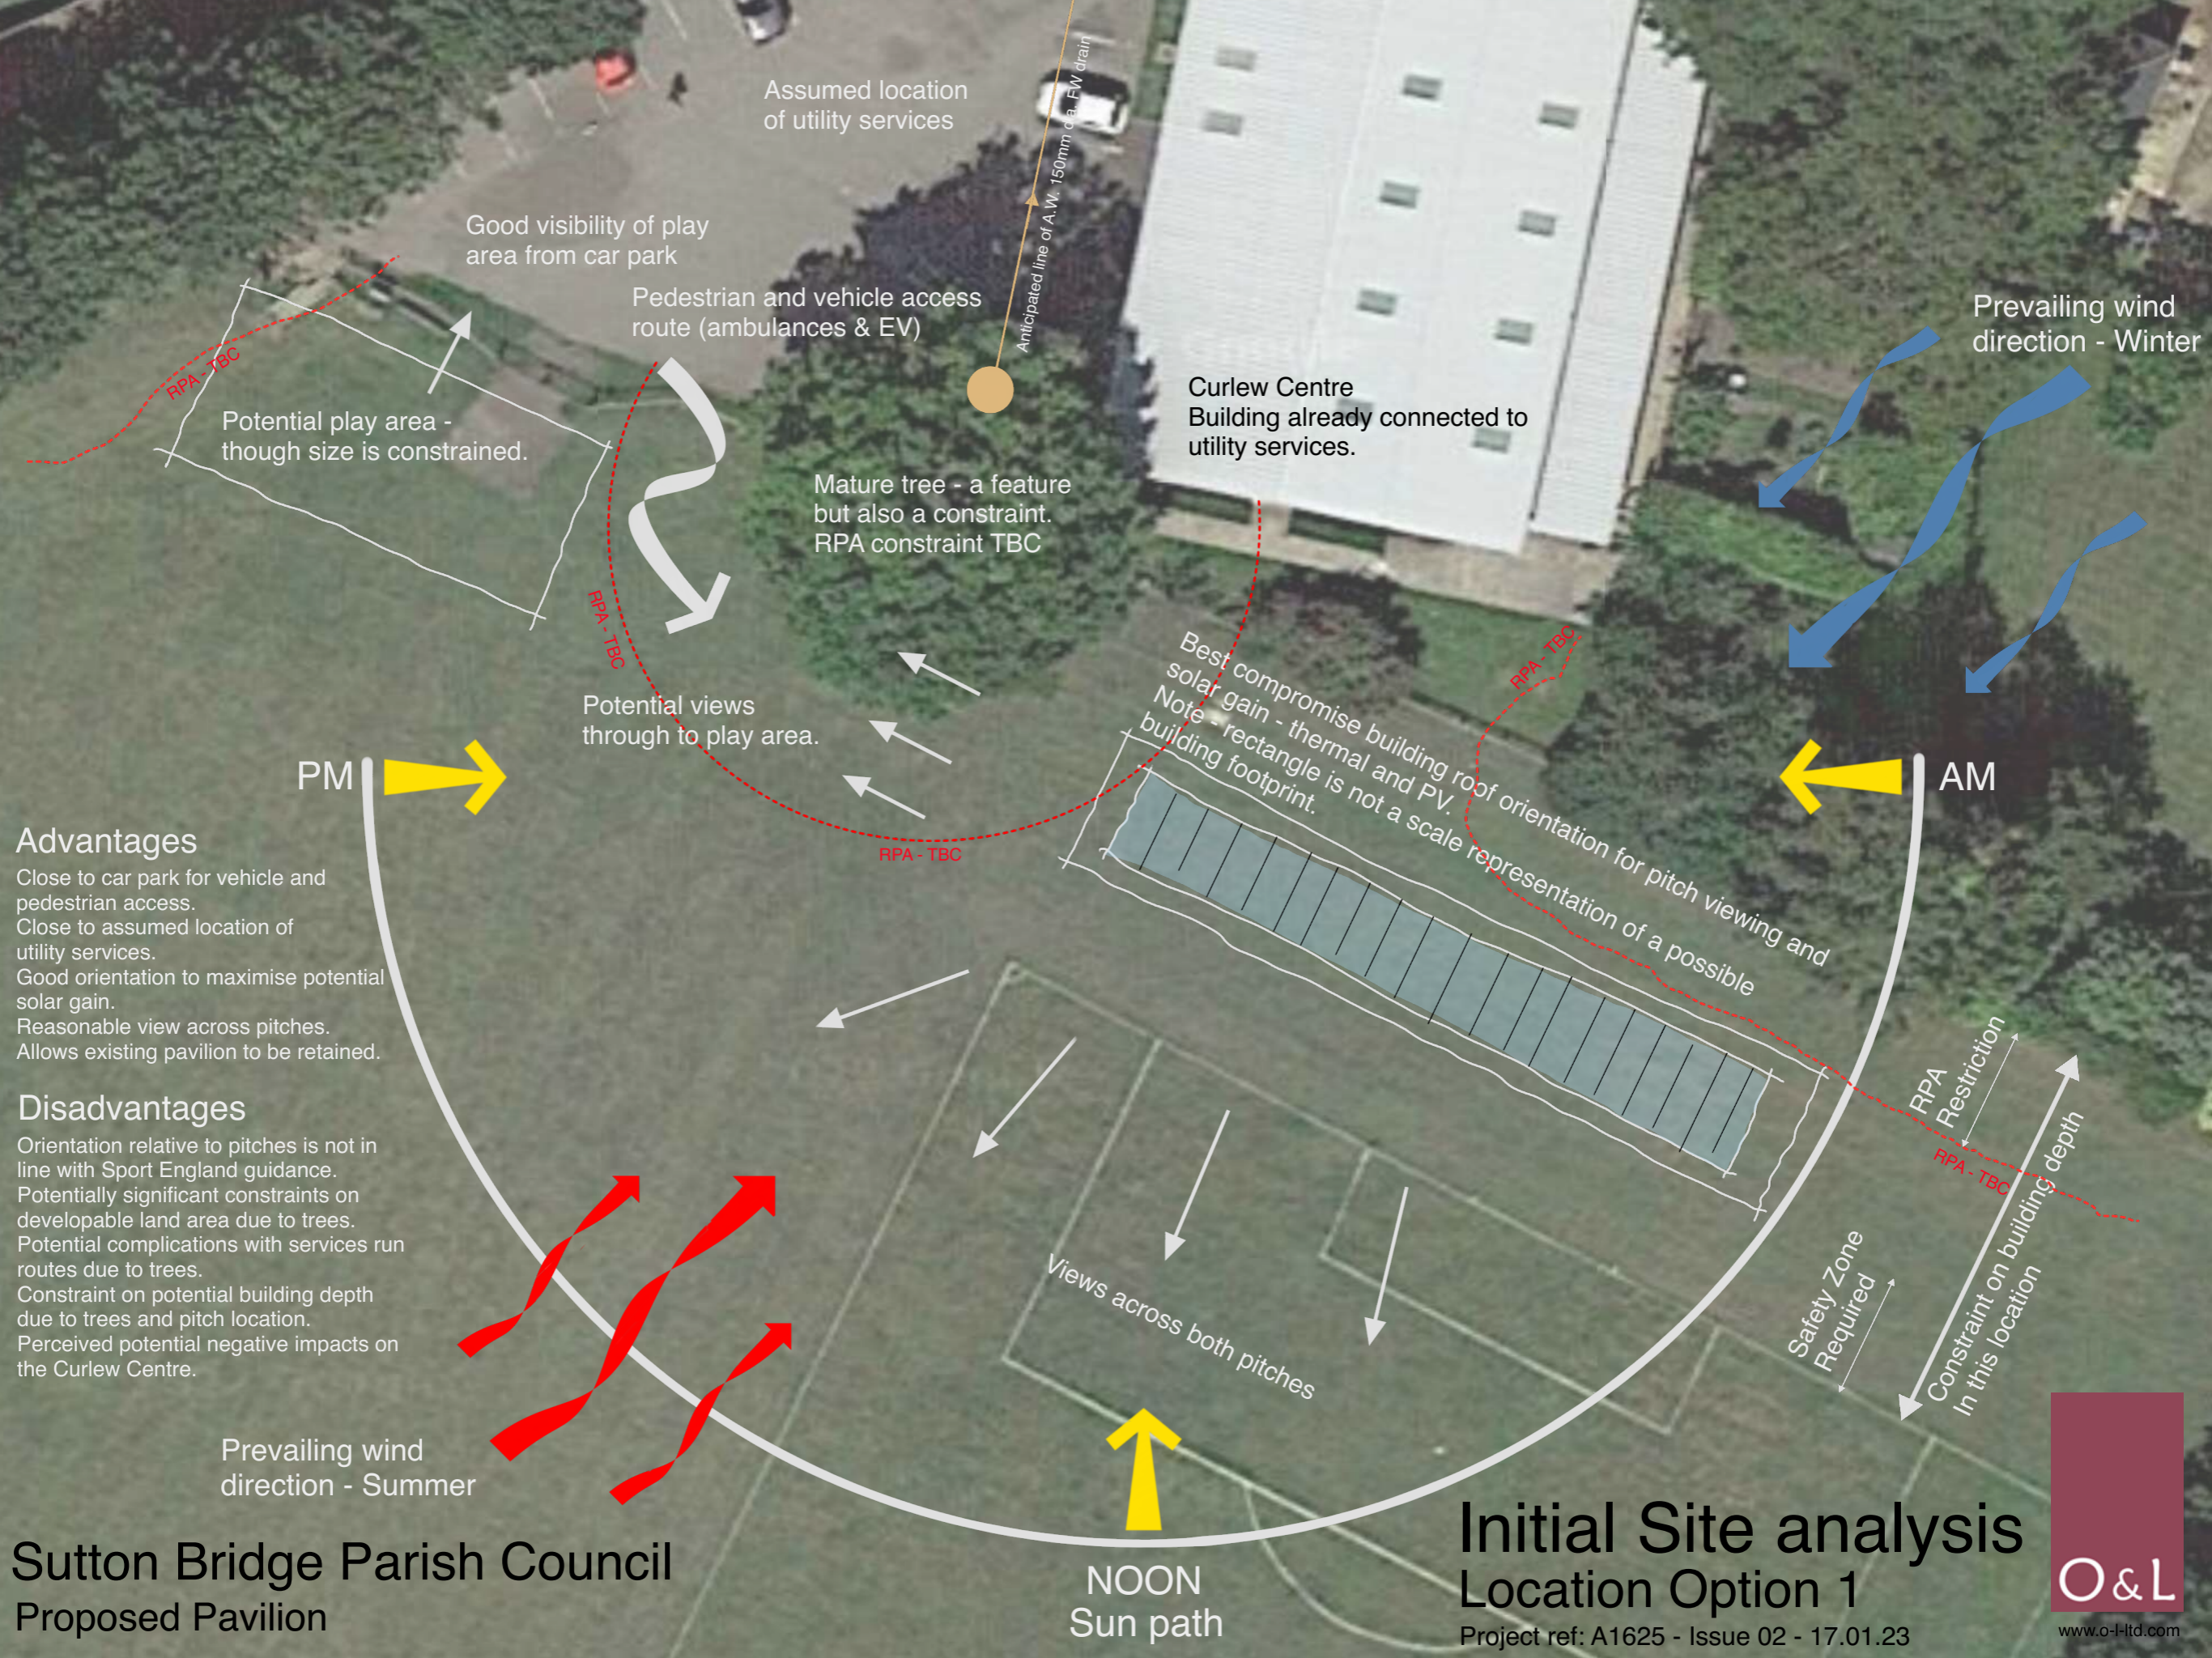
Assumed location of utility services

Good visibility of play area from car park

Pedestrian and vehicle access route (ambulances & EV)

Anticipated line of A.W. 150mm dia. FW drain

Curlew Centre Building already connected to utility services.

Prevailing wind direction - Winter

Potential play area - though size is constrained.

Mature tree - a feature but also a constraint. RPA constraint TBC

Potential views through to play area.

Best compromise building roof orientation for pitch viewing and solar gain - thermal and PV. Note - rectangle is not a scale representation of a possible building footprint.

- Close to car park for vehicle and pedestrian access.
- Close to assumed location of utility services.
- Good orientation to maximise potential solar gain.
- Reasonable view across pitches.
- Allows existing pavilion to be retained.

- Orientation relative to pitches is not in line with Sport England guidance.
- Potentially significant constraints on developable land area due to trees.
- Potential complications with services run routes due to trees.
- Constraint on potential building depth due to trees and pitch location.
- Perceived potential negative impacts on the Curlew Centre.

RPA Restriction

Safety Zone Required

Constraint on building depth In this location

Views across both pitches

Prevailing wind direction - Summer

NOON Sun path
